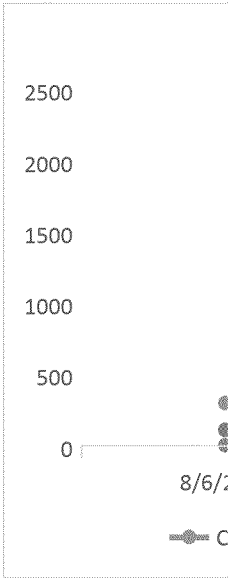
Location: Bakers Bridge

ocation ID	De Sampled	Cadmium	Copper	Lead	Manganes	Zinc
Bakers Bri	8/6/2015	0.336	1.88		296	110
Bakers Bri	8/6/2015	5.32	189	1.56	2090	1700
Bakers Bri	8/5/2015	0.353	2.28		306	85.8
